PVC liners prolong the life of steel and FRP tanks

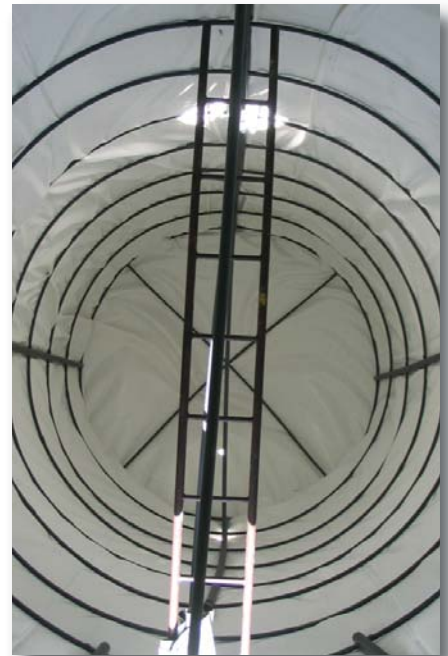
In November 2007, Kentain began the installation of the two liners in the FRP tanks. One tank measured 8'-0" diameter x 12'-0" deep and the other measured 10'-0" diameter x 12'-0" deep.

The preparations for a vertical tank are the same as those for a horizontal tank. Once the tank is ready, the liner is passed through the manway and unrolled onto the floor of the tank. Instead of an internal rib cage, ropes are attached to the roof of the liner and the liner is lifted and attached to the roof of the tank. Again, no bonding of the liner to the tank is required. The liner becomes freely suspended.
